Southeastern Refractory

A Shotcreting Repair on a Aluminum
35Ton Reverb

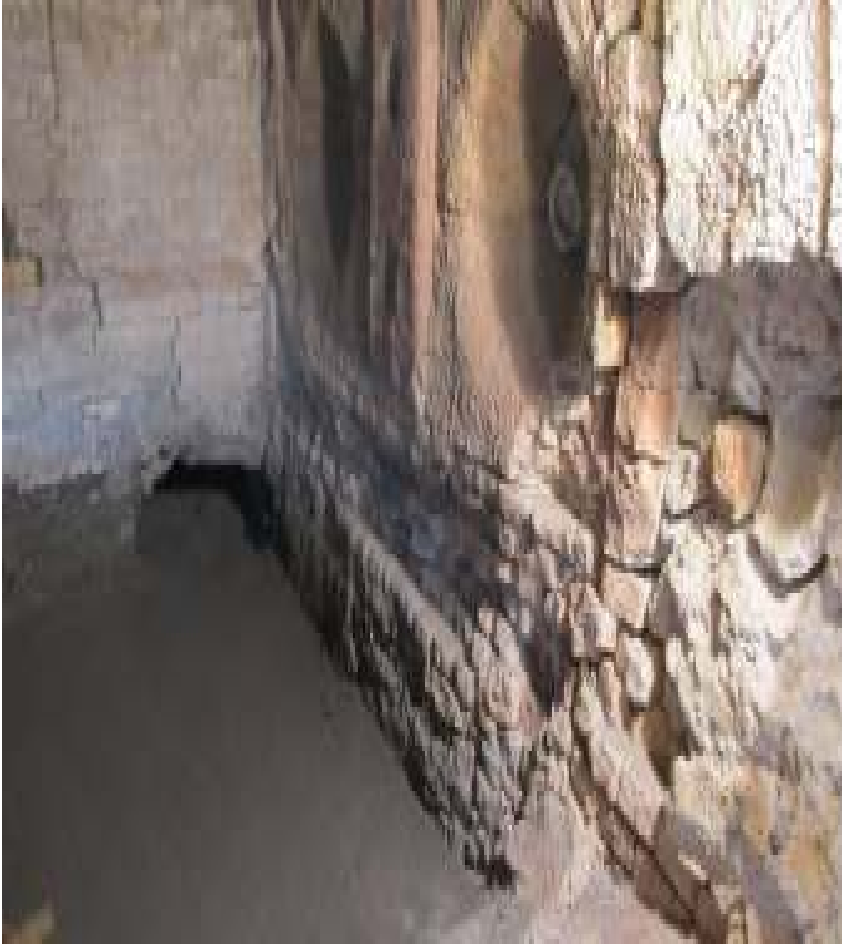
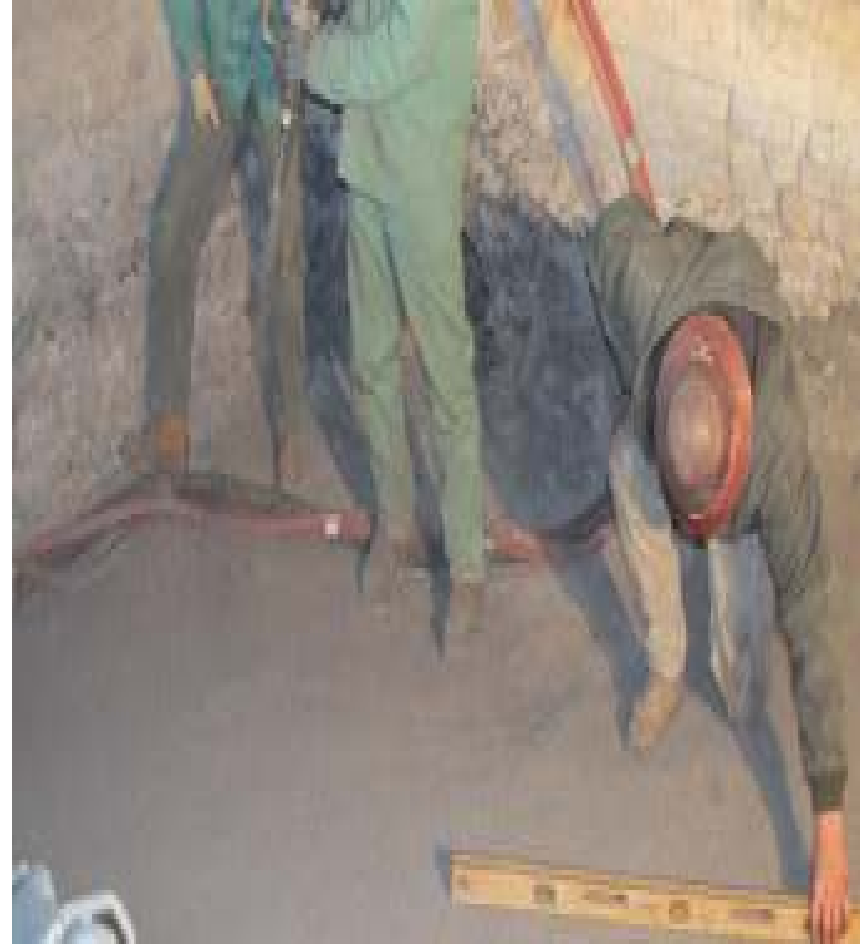
Repair Started in Floor

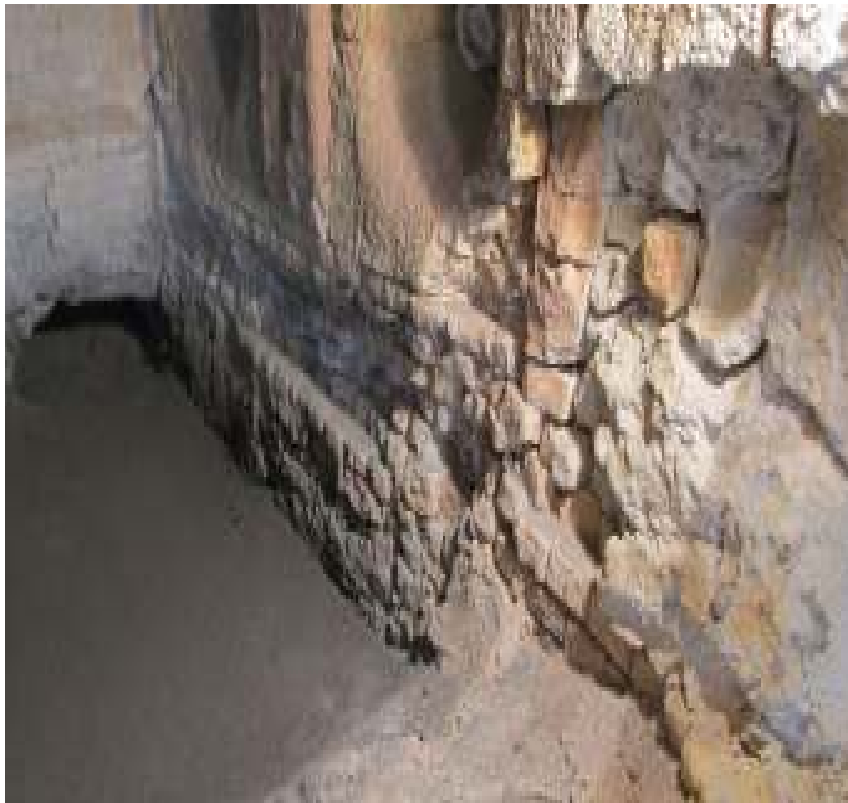
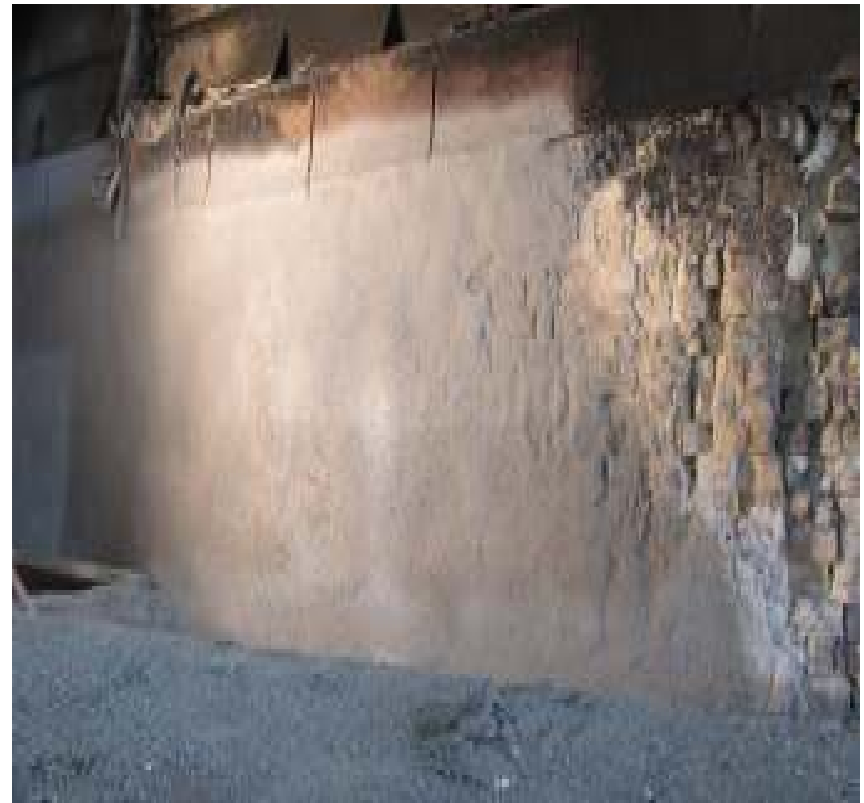
Started Shotcreting Side walls

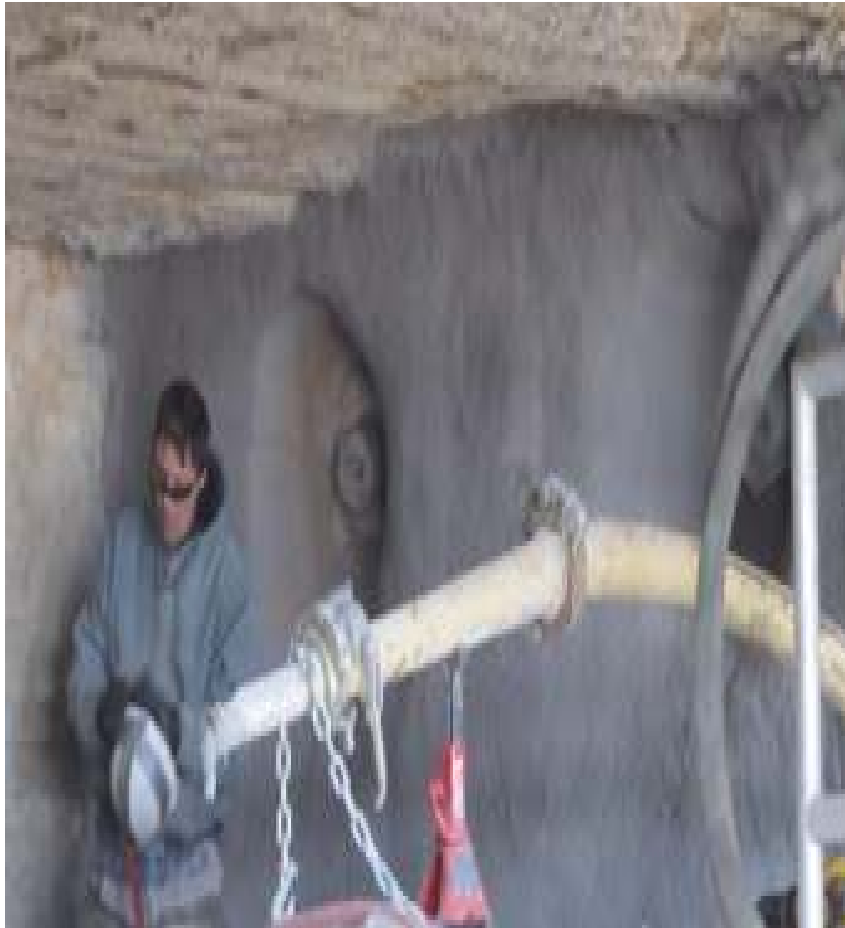
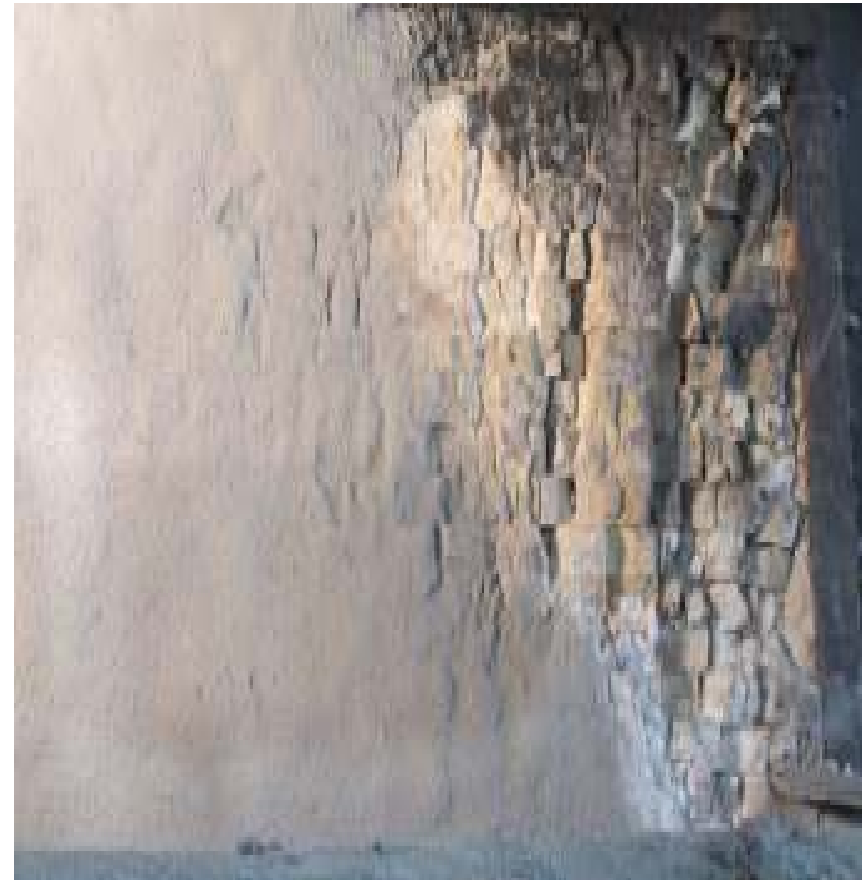
Side walls are almost completed

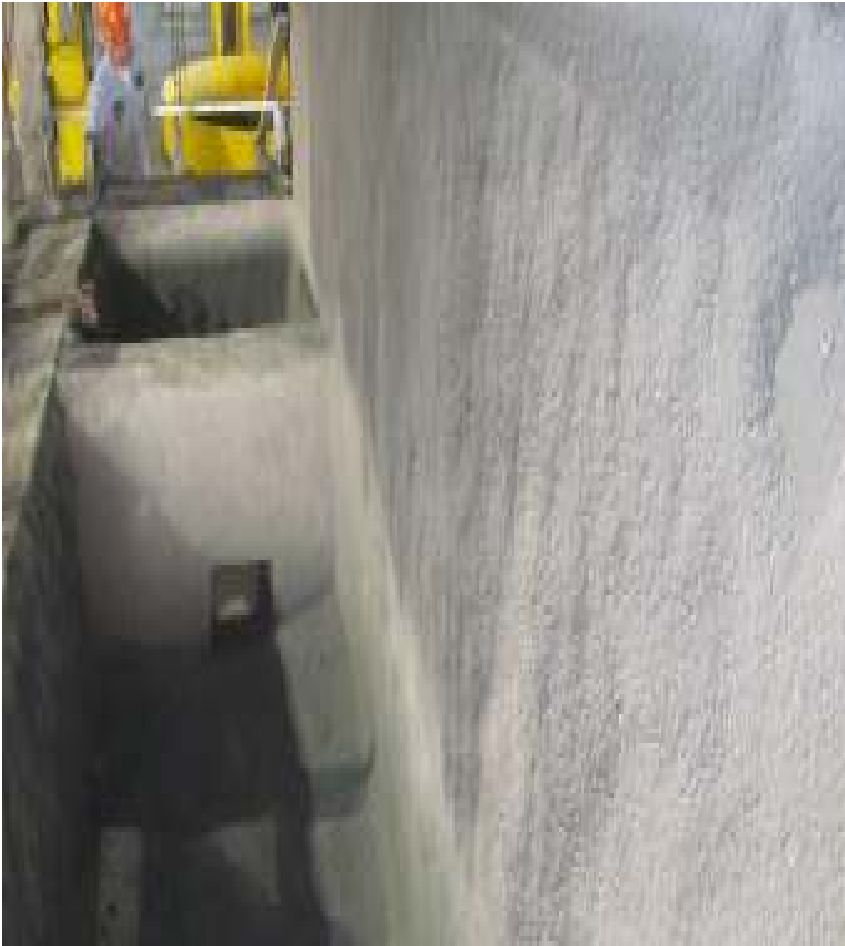
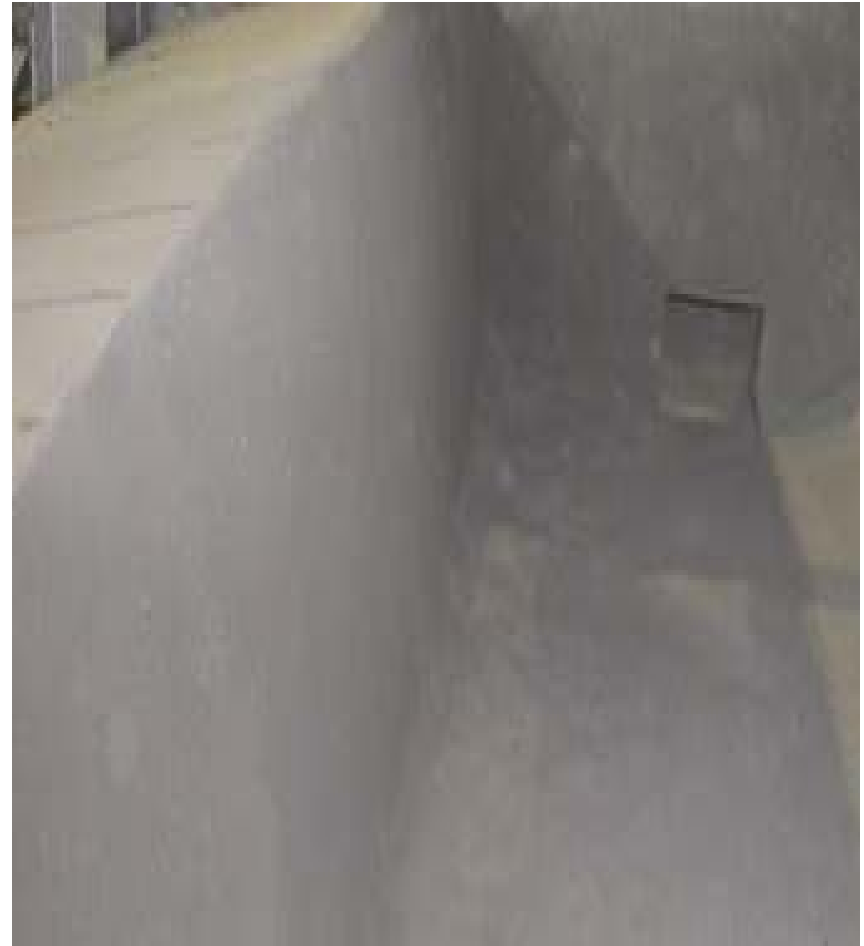
Charge Well and hot wall Completed

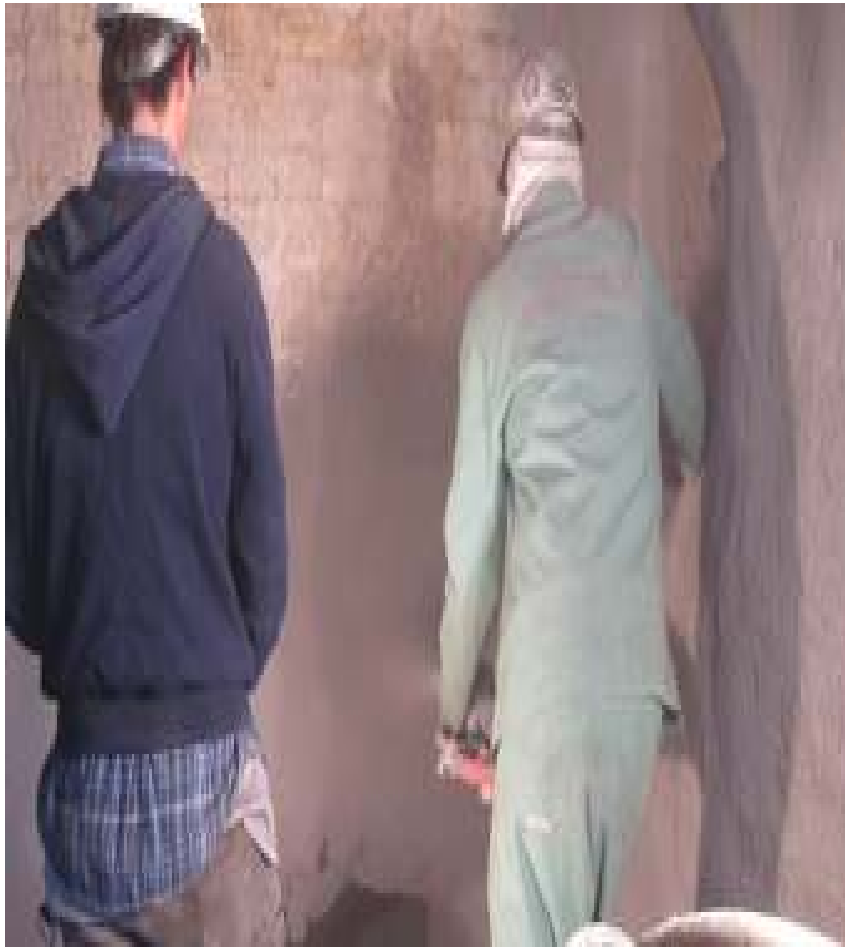
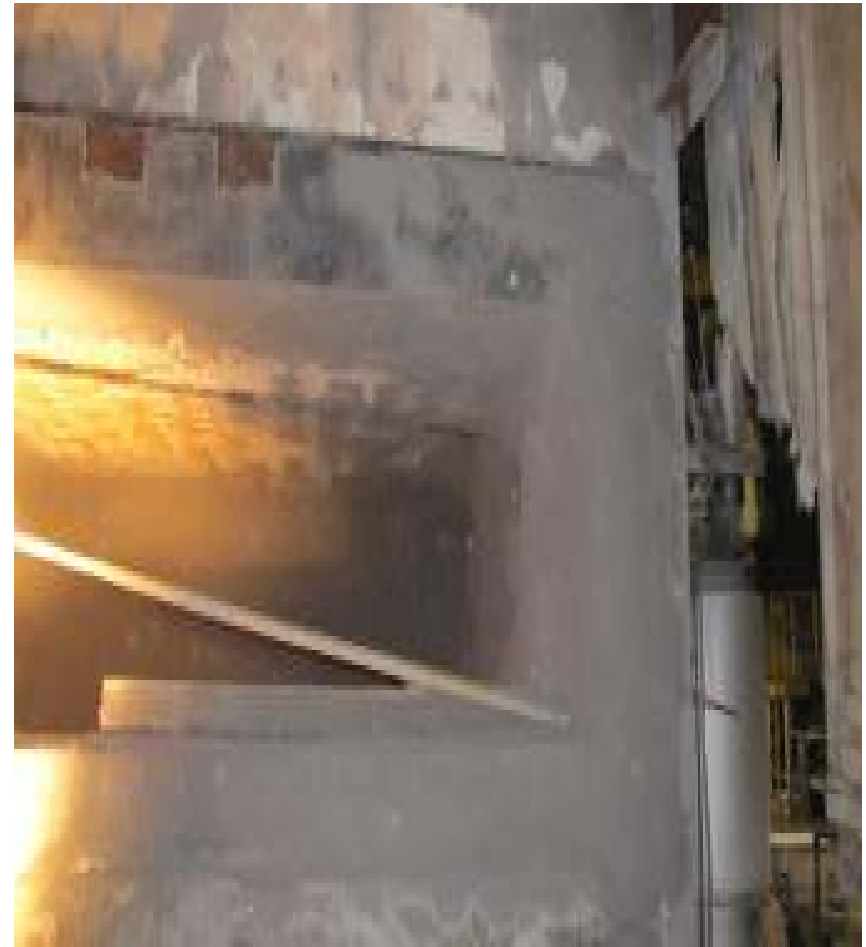
Shotcreting side walls

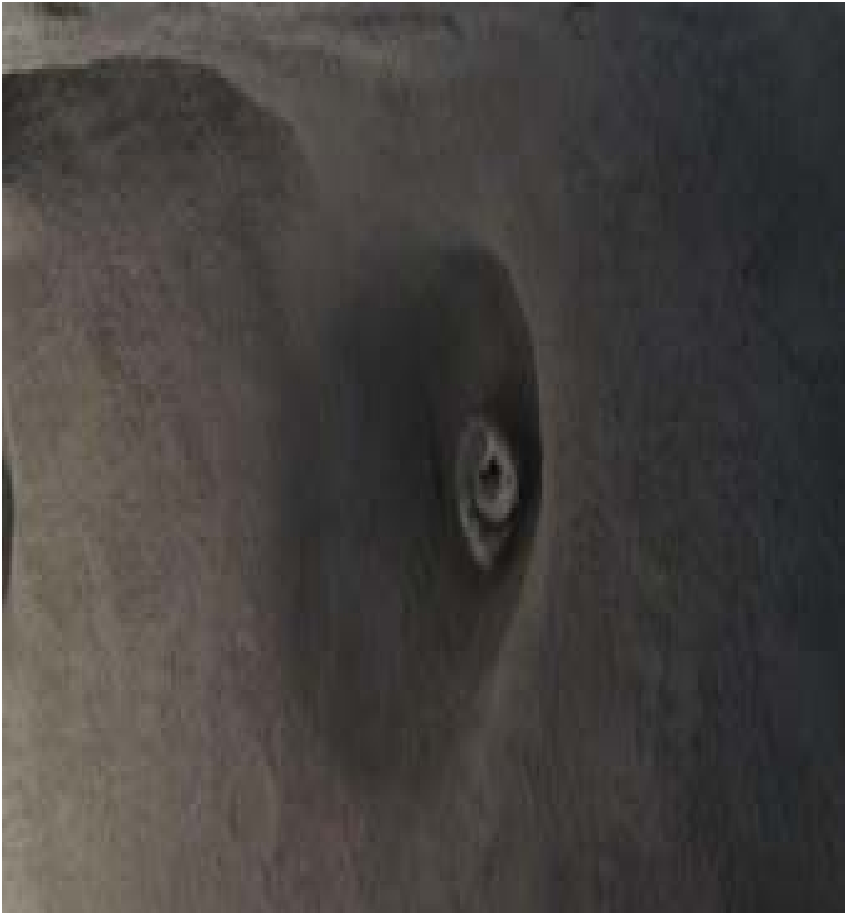
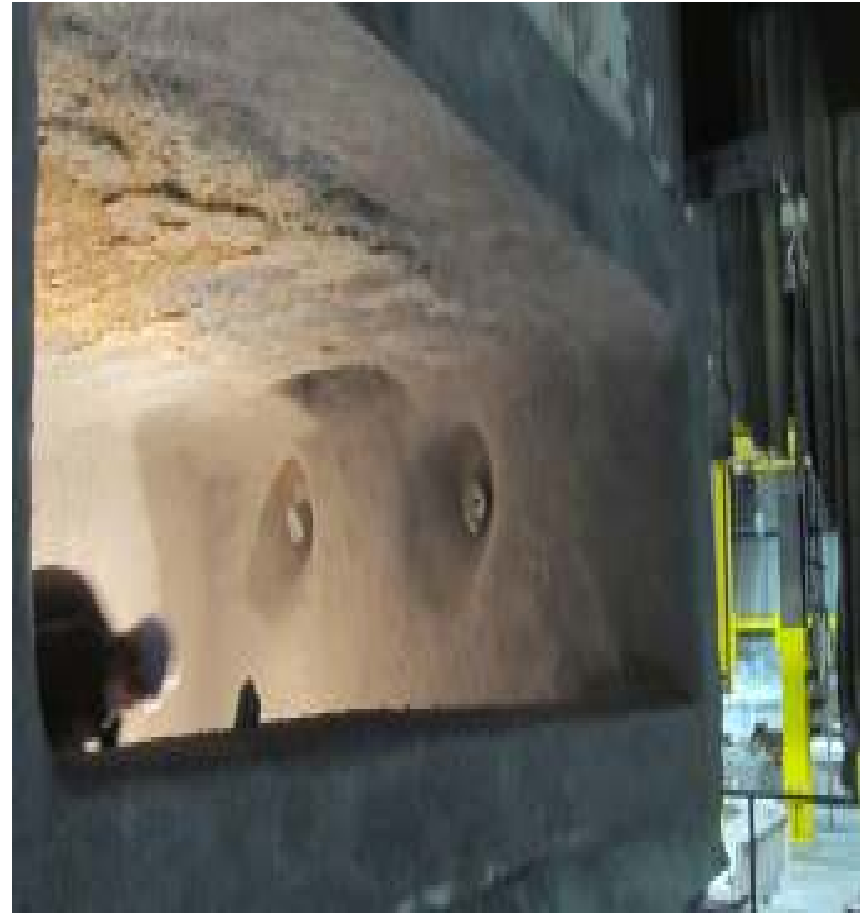
Burner Wall Completed

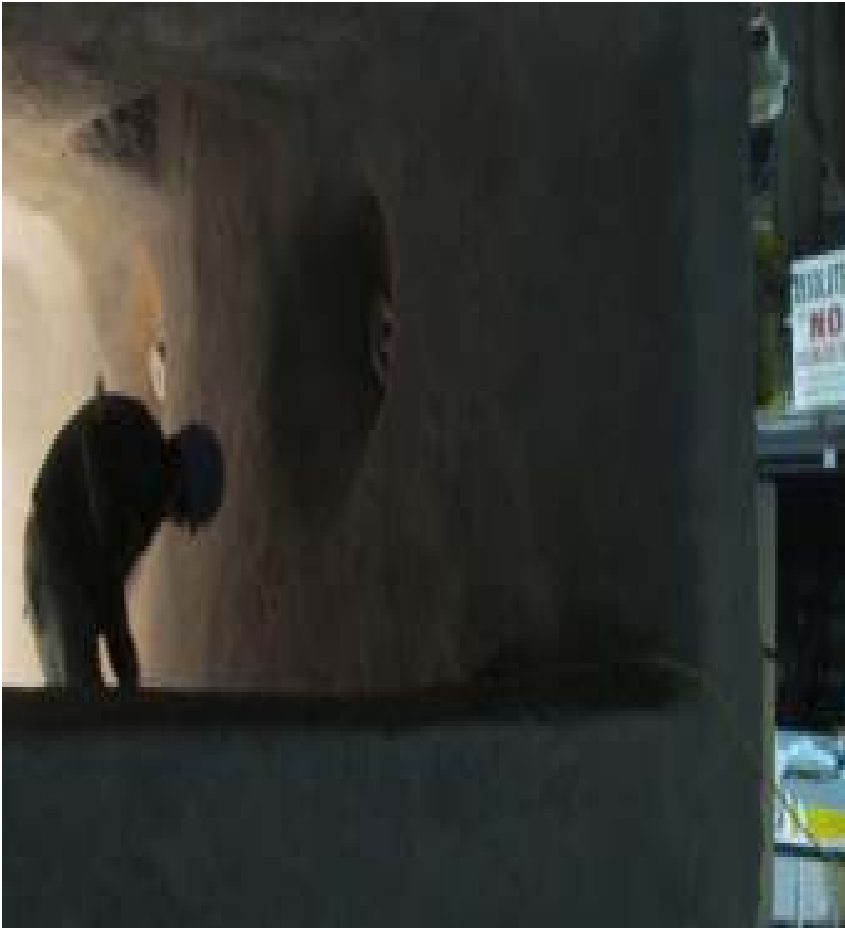
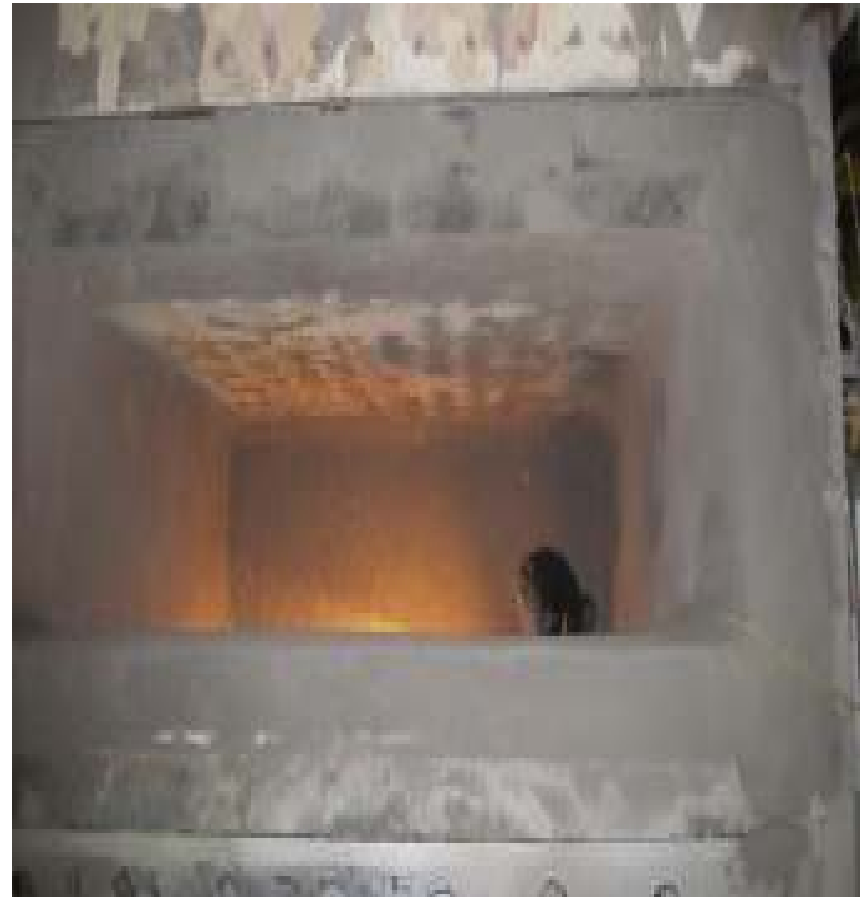
A few final touches

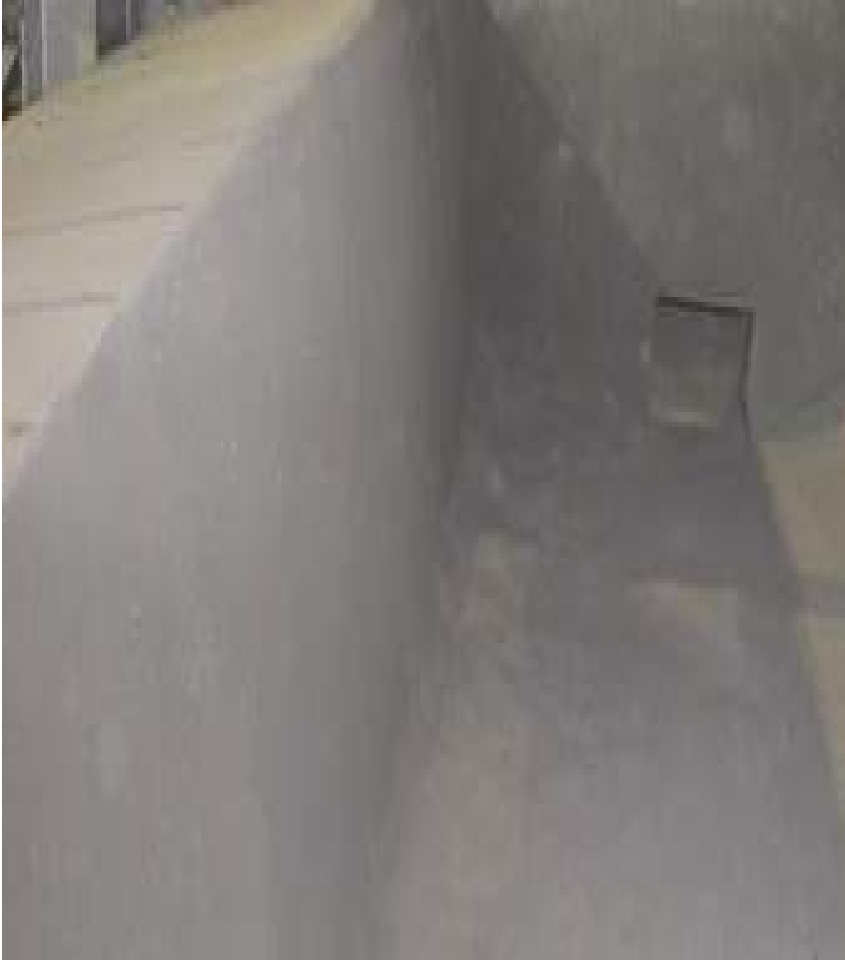
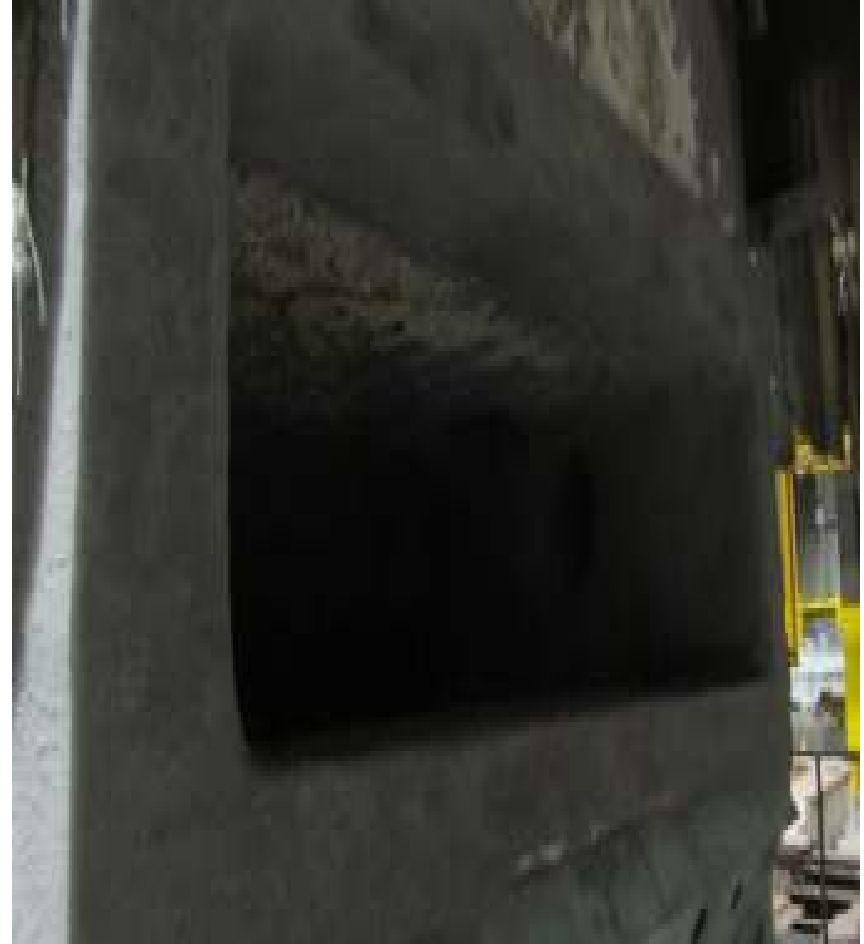
35 ton repair completed
